HOLMES STEM ACADEMY

Outlet Sampling and Plumbing Assessment Recommendations

6602 Oxley Drive, Flint, Michigan 48504

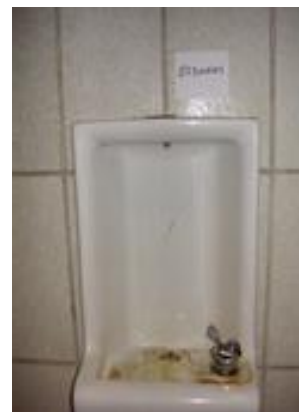
Outlet: Bubbler Fountain (01DW001)

Location: Boys Locker Room, North Wall

Results: P1= 17 parts per billion, P2= 12 parts per billion
F01= 5 parts per billion, F02=5 parts per billion

These results suggest the highest contribution of lead may be from the bubbler itself. The bubbler is chrome-plated brass. The connecting piping to the unit also contains some brass components, including brass fittings and a brass valve.

Replacement of this bubbler and its connecting plumbing with lead-free materials will significantly reduce lead exposure at this location. If replacement is not currently feasible, sample results indicate that flushing this tap for three minutes following periods of stagnation is likely to reduce lead concentrations and lead exposure.

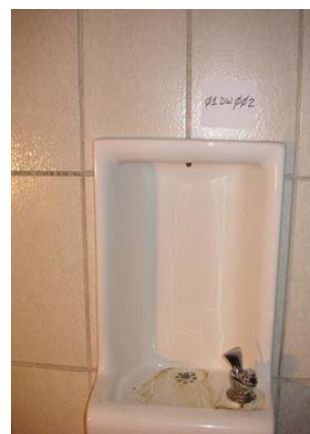
Outlet: Bubbler Fountain (01DW002)

Location: Girls Locker Room, South Wall

Results: P1= 18 parts per billion, P2=9 parts per billion
F01=9 parts per billion, F02=4 parts per billion

These results suggest the highest contribution of lead may be from the bubbler itself. The bubbler is chrome-plated brass. The connecting piping to the unit also contains some brass components, including brass fittings and a brass valve.

Replacement of this bubbler and its connecting plumbing with lead-free materials will significantly reduce lead exposure at this location. If replacement is not currently feasible, sample results indicate that flushing this tap for three minutes following periods of stagnation is likely to reduce lead concentrations and lead exposure.

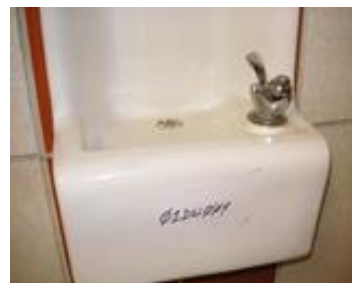
Outlet: Bubbler Fountain (01DW004)

Location: Hallway Across from Girls Locker Room, West Side

Results: P1=16 parts per billion, P2=4 parts per billion,
F01=3 parts per billion, F02=2 parts per billion

These results suggest the highest contribution of lead may be from the bubbler itself. The bubbler is chrome-plated brass. The connecting piping to the unit also contains some brass components, including brass fittings and a brass valve.

Replacement of this bubbler and its connecting plumbing with lead-free materials will significantly reduce lead exposure at this location. If replacement is not currently feasible, sample results indicate that flushing this tap for three minutes following periods of stagnation is likely to reduce lead concentrations and lead exposure.

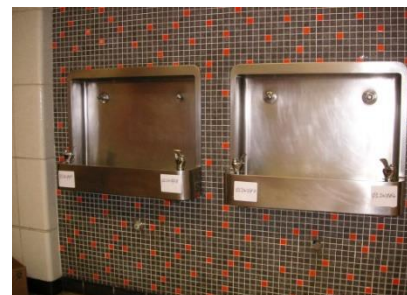
Outlet: Bubbler Fountains (01DW006, 01DW007, 01DW008, 01DW009)

Location: Cafeteria, South Wall

Results: P1= 22 parts per billion, P2=20 parts per billion
F01=5 parts per billion, F02=4 parts per billion

Results: P1=15 parts per billion, P2=5 parts per billion
F01=4 parts per billion, F02=4 parts per billion

Results: P1=47 parts per billion, P2=8 parts per billion
F01=6 parts per billion, F02=17 parts per billion

Results: P1=22 parts per billion, P2=16 parts per billion
F01=13 parts per billion, F02=8 parts per billion

These results suggest that while the highest contribution of lead may be from the bubblers themselves, sample F02 for bubbler 01DW008 shows additional sources of lead deeper within the supply plumbing. The bubblers are all constructed of chrome-plated brass. Connecting plumbing contains brass connections, brass fittings, brass shut-off valves, and copper piping with lead solder.

Replacement of these bubblers and their connecting plumbing will significantly reduce lead exposure at this location. Further investigation of the supply plumbing in this area is also recommended. If investigation

and replacement is not currently feasible, **SHUT OFF THESE BUBBLER FOUNTAINS AND DO NOT USE FOR DRINKING OR COOKING.**

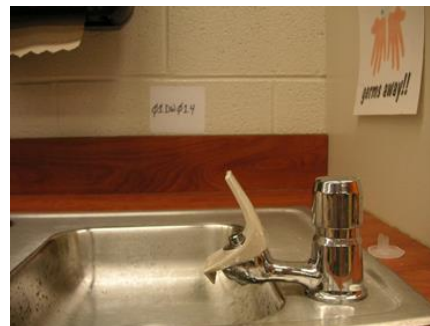
Outlet: Bubbler Fountain (01DW014)

Location: Room B109, West Wall

Results: P1=18 parts per billion, P2=2 parts per billion
F01=non-detect, F02=non-detect

These results suggest the highest contribution of lead may be from the bubbler itself. The bubbler is constructed of chrome-plated brass, with a brass connection on the underside of the sink. The connecting piping to the unit also contains some brass fittings.

Replacement of this bubbler with lead-free materials will significantly reduce lead exposure at this location. If replacement is not currently feasible, sample results indicate that flushing this tap for three minutes following periods of stagnation is likely to reduce lead concentrations and lead exposure.

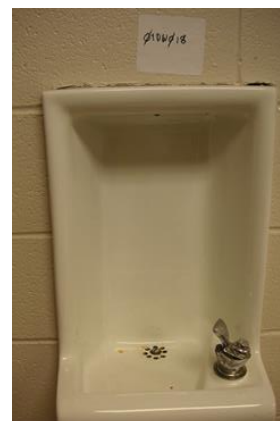
Outlet: Bubbler Fountain (01DW018)

Location: Room B102, North Side of Room

Results: P1=59 parts per billion, P2=35 parts per billion
F01=20 parts per billion, F02=4 parts per billion

These results suggest the highest contribution of lead may be from the bubbler itself. The bubbler is chrome-plated brass. The connecting piping to the unit also contains some brass components, including brass fittings and a brass valve.

Replacement of this bubbler and its connecting plumbing with lead-free materials will significantly reduce lead exposure at this location. If replacement is not currently feasible, sample results indicate that flushing this tap for three minutes following periods of stagnation is likely to reduce lead concentrations and lead exposure.

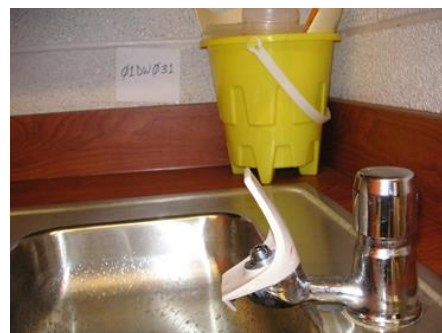
Outlet: Bubbler Fountain (01DW31)

Location: Community Room, West Wall

Results: P1=19 parts per billion, P2=77 parts per billion
F01=4 parts per billion, F02=3 parts per billion

These results suggest the highest contribution of lead may be from the bubbler and its connecting plumbing. The bubbler is constructed of chrome-plated brass and has a brass connection on the underside of the sink.

Replacement of this bubbler and its connecting plumbing with lead-free materials will significantly reduce lead exposure at this location. If replacement is not currently feasible, sample results indicate that flushing this tap for three minutes following periods of stagnation is likely to reduce lead concentrations and lead exposure.

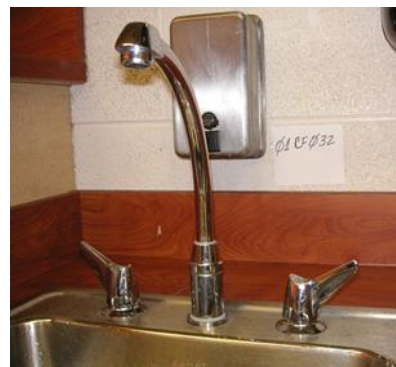
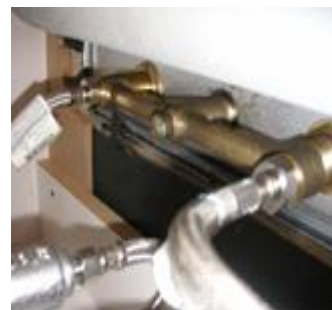
Outlet: Classroom Faucet (01CF32)

Location: Community Room, West Wall

Results: P1=34 parts per billion, P2=15 parts per billion
F01=4 parts per billion, F02=4 parts per billion

These results suggest the highest contribution of lead may be from the faucet and its connecting plumbing. This faucet is an Elkay model that contains a brass mixer fitting on the underside of the sink to connect hot and cold water lines.

Replacement of this faucet and its connecting plumbing with lead-free materials will significantly reduce lead exposure at this location. If replacement is not currently feasible, sample results indicate that flushing this tap for three minutes following periods of stagnation is likely to reduce lead concentrations and lead exposure.

This faucet also has an aerator/screen at the outlet. If the faucet is not replaced, the aerator/screen should be removed, inspected for particulate accumulations, scrubbed clean, and reinstalled. If particulates are found, the aerator/screen should be periodically checked and cleaned.

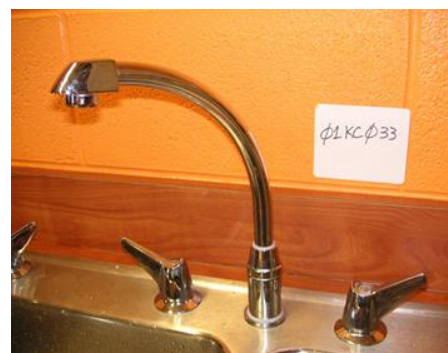
Outlet: Kitchen Faucet (01KC033)

Location: Community Room, South Wall

Results: P1= 700 parts per billion, P2=181 parts per billion
F01=10 parts per billion, F02=2 parts per billion

These results suggest the highest contribution of lead may be from the faucet and its connecting plumbing. This faucet is an Elkay model, with a brass mixer fitting on the underside of the sink to connect hot and cold water lines.

Copper results for sample P2 at this location were also at levels above which the DEQ recommends school facilities take action. Copper results suggest these same brass components are contributing to this condition.

Replacement of this faucet and its connection plumbing with lead-free materials will significantly reduce lead and copper exposure at this location. If replacement is not currently feasible, sample results indicate

that flushing this tap for three minutes following periods of stagnation is likely to reduce lead concentrations and lead exposure.

This faucet also has an aerator/screen at the outlet. If the faucet is not replaced, the aerator/screen should be removed, inspected for particulate accumulations, scrubbed clean, and reinstalled. If particulates are found, the aerator/screen should be periodically checked and cleaned.

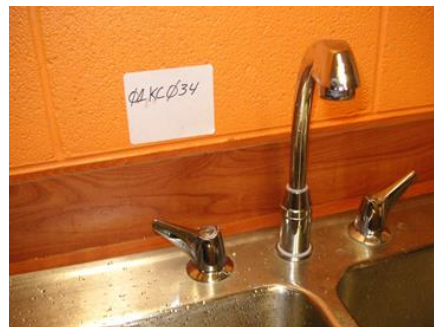
Outlet: Kitchen Faucet (01KC34)

Location: Community Room, South Wall
Results: P1=21 parts per billion, P2=10 parts per billion
F01=3 parts per billion, F02=1 part per billion

These results suggest the highest contribution of lead may be from the faucet and its connecting plumbing. This faucet is an Elkay model, with a brass mixer fitting on the underside of the sink to connect hot and cold water lines.

Replacement of this faucet and its connecting plumbing with lead-free materials will significantly reduce lead exposure at this location. If replacement is not currently feasible, sample results indicate that flushing this tap for three minutes following periods of stagnation is likely to reduce lead concentrations and lead exposure.

This faucet also has an aerator/screen at the outlet. If the faucet is not replaced, the aerator/screen should be removed, inspected for particulate accumulations, scrubbed clean, and reinstalled. If particulates are found, the aerator/screen should be periodically checked and cleaned.

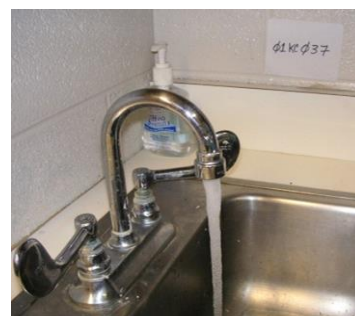
Outlet: Kitchen Faucet (01KC037)

Location: Supply Room, North of Community Room, East Wall
Results: P1= 32 parts per billion, P2=31 parts per billion
F01=8 parts per billion, F02=2 parts per billion

These results suggest the highest contribution of lead may be from the faucet and its connecting plumbing. The connecting piping to the unit also contains some brass components.

Replacement of this faucet and its connecting plumbing with lead-free materials will significantly reduce lead exposure at this location. If replacement is not currently feasible, sample results indicate that flushing this tap for three minutes following periods of stagnation is likely to reduce lead concentrations and lead exposure.

This faucet also has an aerator/screen at the outlet. If the faucet is not replaced, the aerator/screen should be removed, inspected for particulate accumulations, scrubbed clean, and reinstalled. If particulates are found, the aerator/screen should be periodically checked and cleaned.

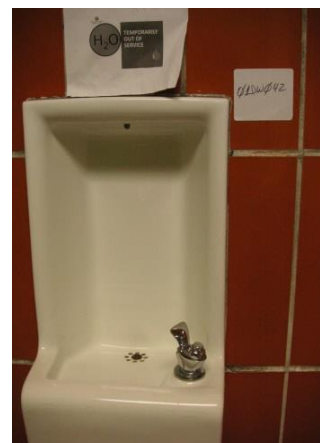
Outlet: Bubbler Fountain (01DW042)

Location: Off of Green Hall, next to Boys Restroom

Results: P1=24 parts per billion, P2=17 parts per billion
F01=4 parts per billion, F02=3 parts per billion

These results suggest the highest contribution of lead may be from the bubbler itself. The bubbler is chrome-plated brass. The connecting piping to the unit also contains some brass components, including brass fittings and a brass valve.

Replacement of this bubbler and its connecting plumbing with lead-free materials will significantly reduce lead exposure at this location. If replacement is not currently feasible, sample results indicate that flushing this tap for three minutes following periods of stagnation is likely to reduce lead concentrations and lead exposure.

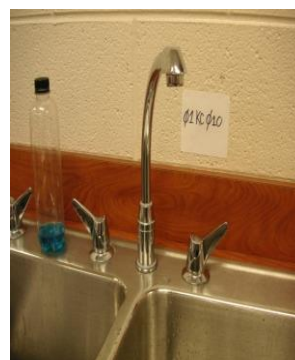
Outlet: Kitchen Faucet (01KC010)

Location: Room B110, East Wall

Results: P1=0.16 parts per million, P2=1.32 parts per million
F01=0.09 parts per million, F02=0.07 parts per million

These results suggest the highest contribution of copper may be from the faucet and its connecting plumbing. This faucet is an Elkay model that contains a brass mixer fitting on the underside of the sink to connect hot and cold water lines. Copper results suggest these brass components are contributing to this condition.

Replacement of this faucet and its connecting plumbing is recommended and will reduce copper exposure at this location. If replacement is not currently feasible, sample results indicate that flushing this tap for

three minutes following periods of stagnation is likely to reduce copper concentrations and copper exposure.

This faucet also has an aerator/screen at the outlet. If the faucet is not replaced, the aerator/screen should be removed, inspected for particulate accumulations, scrubbed clean, and reinstalled. If particulates are found, the aerator/screen should be periodically checked and cleaned.

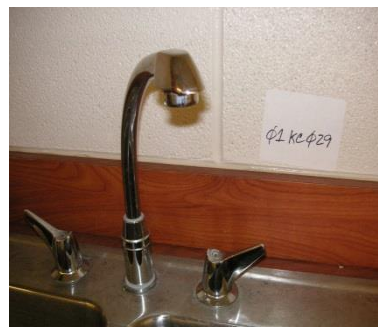
Outlet: Kitchen Faucet (01KC029)

Location: Room B114, East Wall

Results: P1=0.13 parts per million, P2=1.66 parts per million
F01=0.10 parts per million, F02=non-detect

These results suggest the highest contribution of copper may be from the faucet and its connecting plumbing. This faucet is an Elkay model, with a brass mixer fitting on the underside of the sink to connect hot and cold water lines. Copper results suggest these brass components are contributing to this condition.

Replacement of this faucet and its connecting plumbing is recommended and will reduce copper exposure at this location. If replacement is not currently feasible, sample results indicate that flushing this tap for three minutes following periods of stagnation is likely to reduce copper concentrations and copper exposure.

This faucet also has an aerator/screen at the outlet. If the faucet is not replaced, the aerator/screen should be removed, inspected for particulate accumulations, scrubbed clean, and reinstalled. If particulates are found, the aerator/screen should be periodically checked and cleaned.
